68-AG-346

## A MINE FLOOD, VANCOUVER ISLAND

R. L. Loofbourow  
Consulting Engineer

Ernest K. Lehmann  
Consulting Geologist

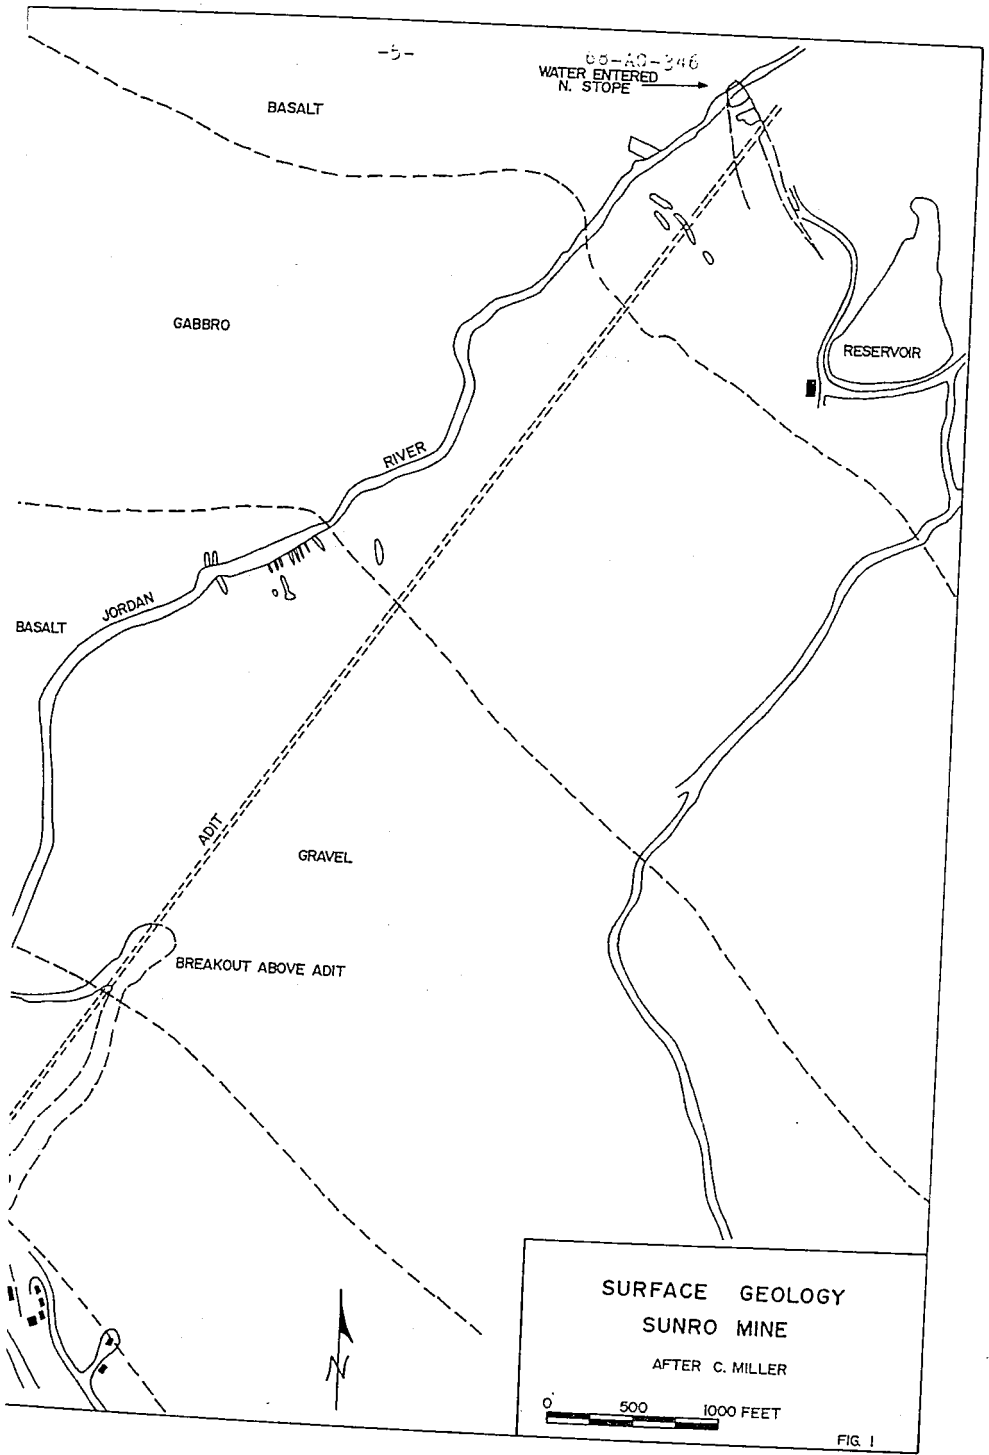
FIG. 1

Annual rainfall is reported to be in the neighborhood of 100 inches concentrated in the autumn and winter. During heavy rains the River can rise five feet in a few hours. On the ridge above the adit through which the mine is entered, the British Columbia Hydro and Power Authority has a reservoir into which it diverts much of the River flow during the drier summer months. See Figure 1.

Except for a little development ore, the mill was supplied from two long-hole stopes, mostly from the larger north stope. The best ore was near the junction of the north and northwest trending fracture zones and the northeast cross structure. This junction was near the north end of the north stope and under the Jordan River as indicated in Figure 1.

05-AD-246  
WATER ENTERED  
N. SLOPE

### SURFACE GEOLOGY SUNRO MINE

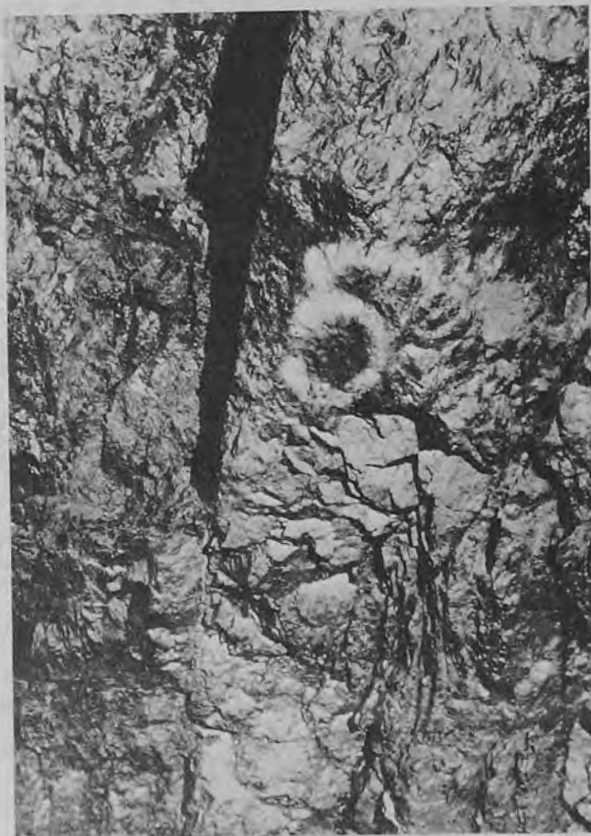
Figure 2

We saw no physical description of the rock cut by holes drilled through the ground which failed. Holes which cut the N45E fracture system several hundred feet below the adit level were reported to have found some open fractures, broken ground and mud. In the stopes and development headings which were accessible after the flood, evidence of tight ground was strong. This evidence included puddles of water on drift floors near open raises, water marks indicating that air had been trapped in raises as the pressure rose, and the almost complete absence of leakage from the North Stope when full of water to nearby workings. See Figures 2 and 3.

A "B" Fracture (approx. N20W) in the 5210 Slusher Drift. The right-hand edge of heavy shadow is on the fracture plane. Platy material below the numeral is basalt. Elsewhere there is disseminated chalcocopyrite.

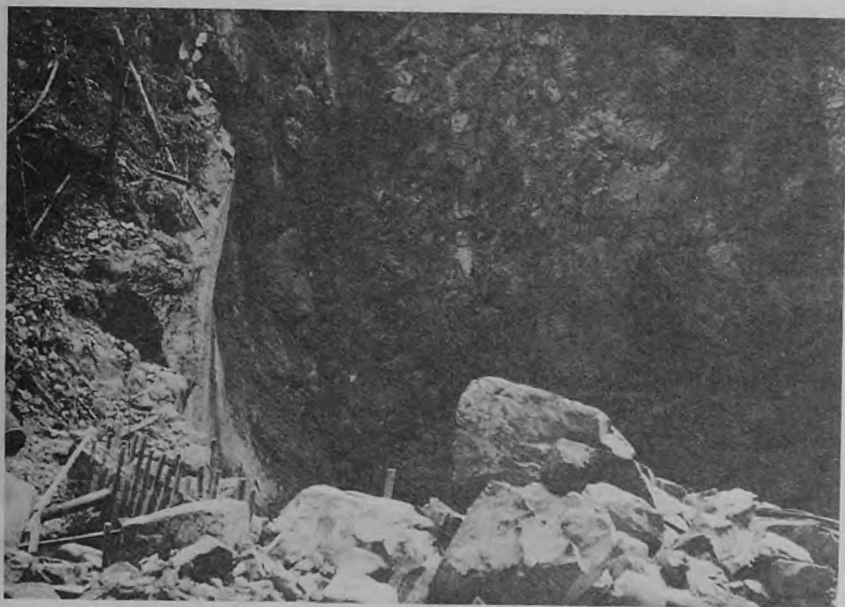
Figure 3

Strong N20W Fractures on left-hand (upstream) side of the caved stope, looking southeast from pile of boulders between the stope and the diverted River. Low diversion dam at lower left. Photograph taken May 4, 1964 just after the mine and the flooded stope had been dewatered. The River was low.

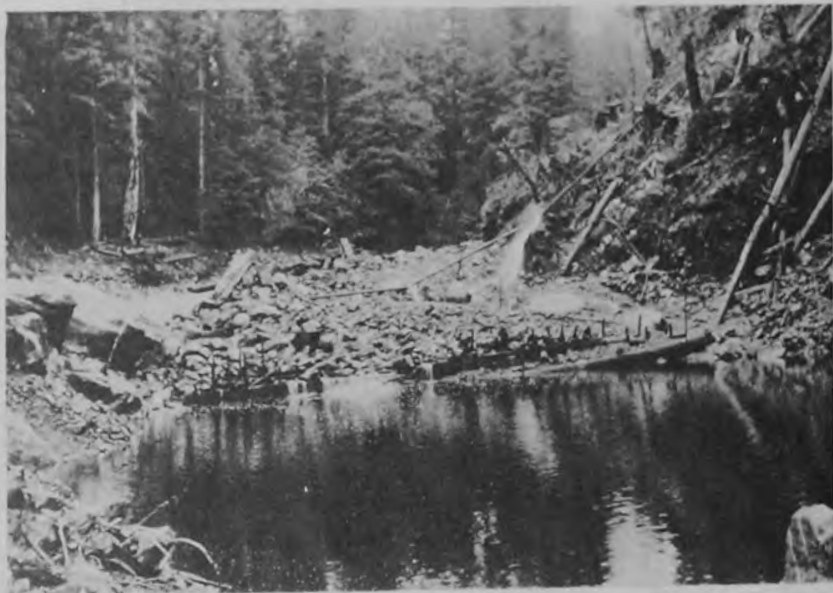
Figure 4

Looking upstream across the flooded slope. Low diversion dam is seen at far edge of water. Trees on the upper third of the photograph are on the far (NW) side of the Jordan River. The photograph was taken December 4, 1964 at time of high water. After the mine was dewatered, bulkheads were built to confine water in the slope and it was allowed to refill.

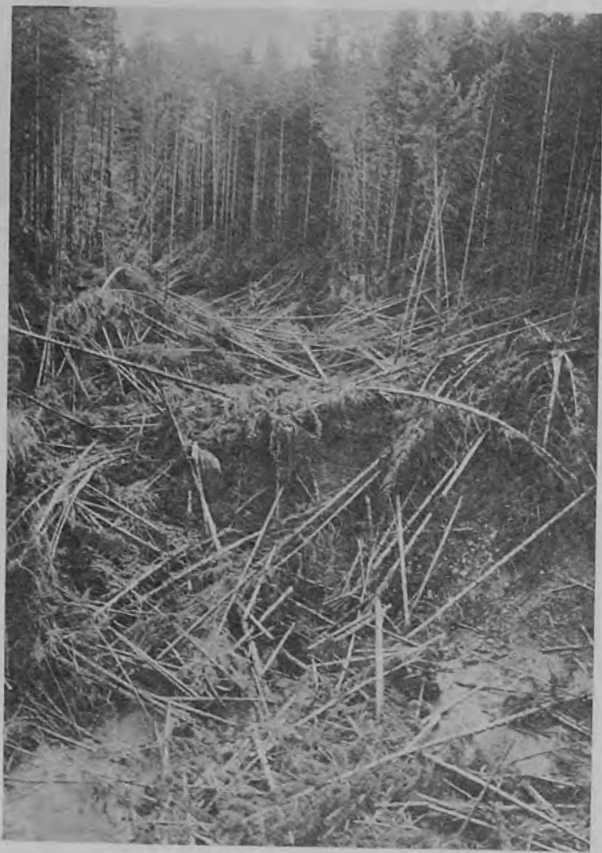
Figure 5

moved by it, the back of the adit apparently began to cave. At the end of the month flow at the portal stopped, and virtually the full tunnel flow burst out on the ridge at an elevation about 250 feet above the adit. At this point there is at least 100 feet of unconsolidated material. The flow of water ground-slucied a deluge of water, trees, sand and boulders toward the River. In passing it took out the timber at the portal and a trestle connecting the portal with shops, warehouse and office, threatening these buildings. As the weak ground in the adit caved, it seems probable that a large chunk of rock fell into the fast moving current and was slammed into or against the outlet toward the portal, quickly plugging this outlet. No one knows just how suddenly this may have happened, but imagine the water-hammer which could be generated by a column of water about 9 x 9 feet in section, 6 000 feet long, moving under a head which approached 470 feet! A crater about 200 feet wide and 60 to 100 feet deep was formed at the surface and a gash of varying dimensions was cut from it through the portal to the River. See Figure 5.

Part of the Blow-Out above the Adit, May 4, 1964. Note the swath cut through the timber above the center of the photograph.

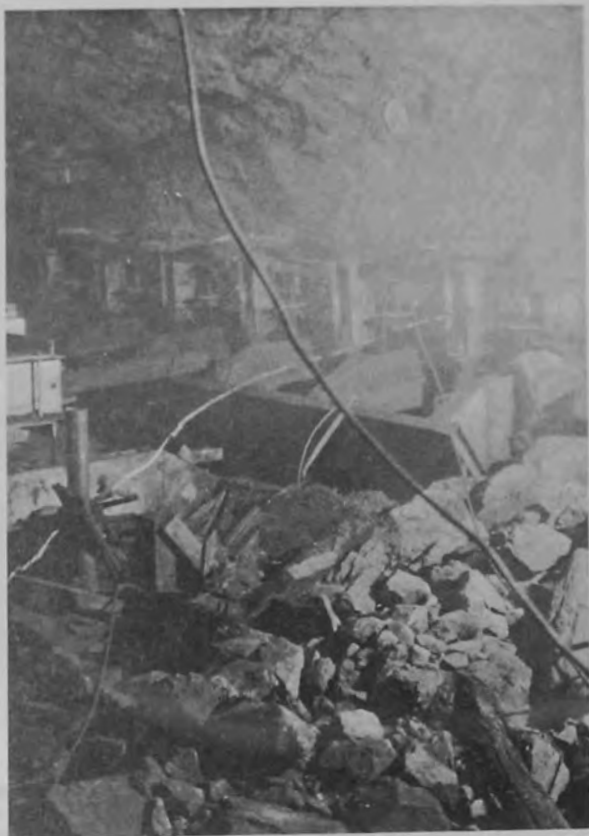
Figure 6

Flotation Section of the Concentrator

Cells have been cleaned out and motors removed for cleaning but rock in foreground could not be moved until the adit was opened.
