**Puntledge River (Reach C) Spawning  
Gravel Placements for Fish Habitat Restoration, 2006**

March 2007

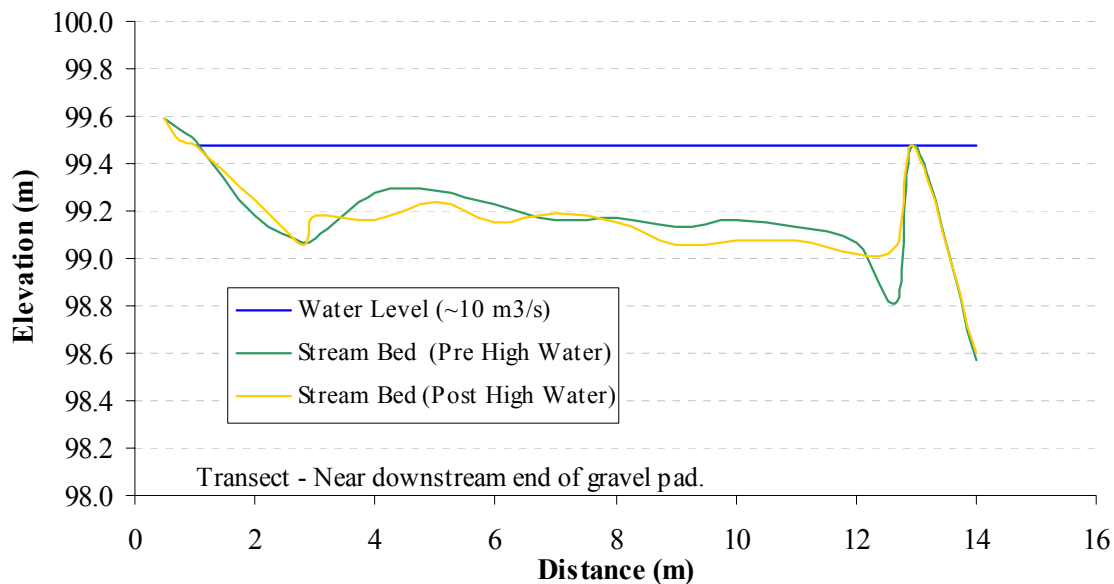
**Figure 3.** Gravel pad profile at Site 1 before (September 15, 2006) and after (March 23, 2007) high water events. Gravel and water heights are referenced to a benchmark arbitrarily set at 100 m.

At Site 1, streambed profiles confirmed snorkel survey observations noting little gravel movement following high water (Figure 3). An overall flattening of the gravel pad appears to have occurred as a result of high water, with a small amount of gravel displaced from its downstream edge into the tail-out of the pool near right bank.

At Site 1, very little gravel movement was noted. Approximately 8.0 m<sup>3</sup> of gravel was displaced from the thalweg edge of the gravel pad, while only a minor amount (<1%) was displaced from the downstream edge of the pad. Most of the displaced gravel appeared to have sloughed off the edge of the pad into pool. Water depth and velocity over the pad appeared poor for spawning at the observed discharge of 5.7 m<sup>3</sup>/s. This site would likely become more suitable at flows greater than 20 m<sup>3</sup>/s. To assess suitability at higher flows, the site was examined on January 9, 2007 when discharge was approximately 70 m<sup>3</sup>/s. Spawning conditions at this discharge appeared highly suitable, as water depth and velocity over the pad was estimated to average 0.7 m and 0.5 m/s, respectively.

Approximately 70% of the gravel pad was covered with a thin layer of dead algae/sediment. Higher velocity areas around complexing rocks and locations where fish had been digging appeared clean. A total of four redd/test redds were noted on this pad. Hand excavation in two of these locations was performed, however no eggs were found. Bone pieces from several salmon carcasses were noted along parts of the pad and along the right bank of the river. No erosion or damage was noted on the re-constructed portion of the dike adjacent to the BC Hydro penstock road.

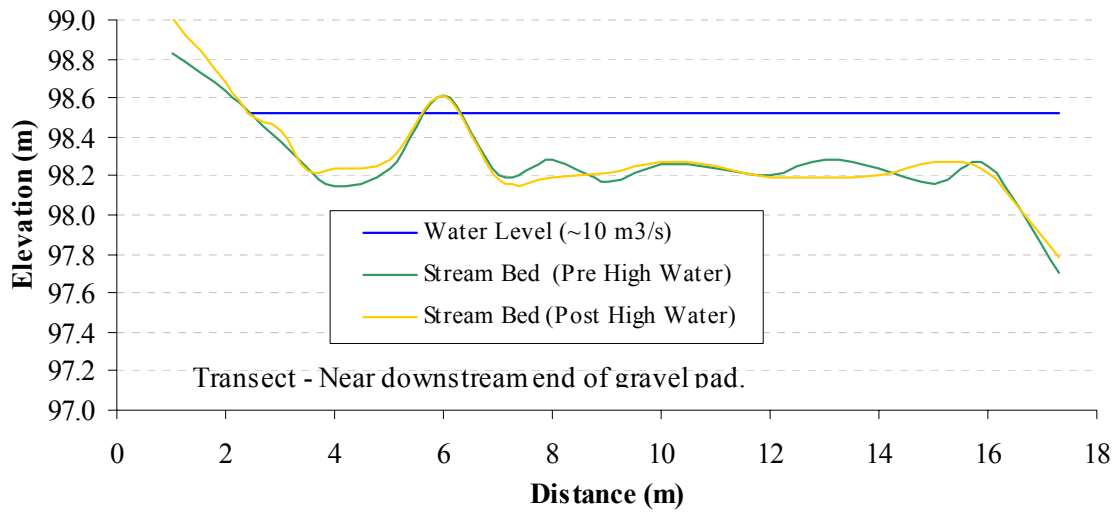
**Figure 4.** Gravel pad profile at Site 2 before (September 15, 2006) and after (March 23, 2007) high water events. Gravel and water heights are reference to a benchmark arbitrarily set at 100 m.

At Site 2, transect data confirmed only minor gravel movement (Figure 4). Similar to the monitoring results from December, a small amount of gravel near the upstream end of the pad appears to have been displaced downstream resulting in a slight increase in pad profile along the transect line.

At Site 2, very little gravel movement (<5%) was observed on December 5. Minor displacement was noted from the pads leading edge towards more central locations. No gravel displacement was noted on the rest of the pad and no material was observed in downstream habitats. Water depth and velocity over the pad appeared poor for spawning at the observed discharge of 5.7 m<sup>3</sup>/s. As with Site 1, conditions here would become more suitable at flows greater than 20 m<sup>3</sup>/s. An on-site visit on January 9, 2007 confirmed better spawning conditions for fish at the observed discharge of approximately 70 m<sup>3</sup>/s. Water depth over the pad was estimated at 0.5 m, while water velocities were estimated between 0.75 and 1.0 m/s.

A couple of depressions were noted near the downstream edge of the pad, possibly indicating spawning activity, however limited hand excavation revealed no eggs present. No erosion or damage was noted on the access road, originally constructed for the Bull Island Side-channel project.

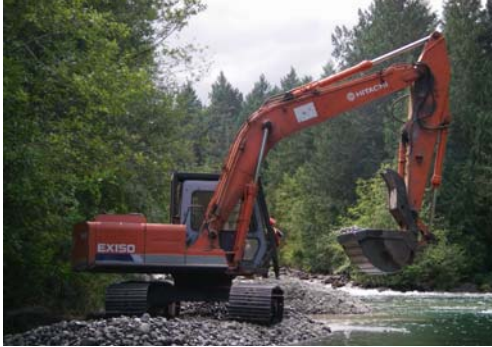
1. Gravel placement by excavator at Site 1 (Barber's Pool).

Construction of the spawning platform at Site 1 commenced on August 23, 2006. As gravel was delivered on-site and dumped on the access ramp, the excavator hoe-chucked the material instream. As with the other sites, boulders were placed on top of the pad and at its downstream end.

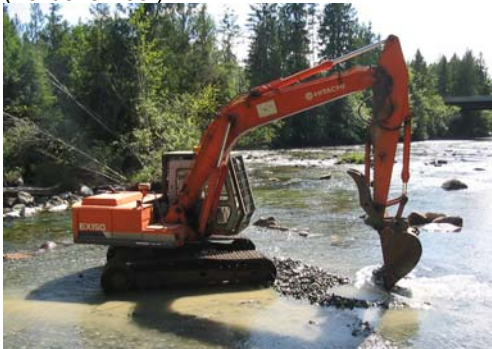
3. Gravel placement by excavator at Site 2 (upstream Bull Island Side-channel intake).

On August 11, gravel staged on the access ramp at Site 2 was mobilized instream by excavator. Spawning gravel was hoe-chucked into position and spread to create the spawning platform. Boulders were placed throughout the platform and at its downstream end to increase stability and create roughness.

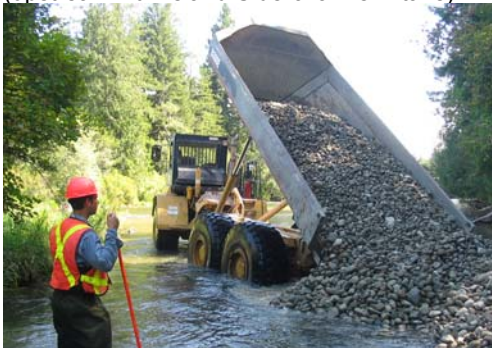
5. Gravel placement by articulated hauler at Site 3 (opposite Bull Island S/C outlet).

Construction began at Site 3 on August 10. The excavator stockpiled into a 6-WD Caterpillar 25 ton articulated hauler. Gravel was forwarded into the river channel and dumped in position. The excavator then spread and roughly leveled the gravel to create the spawning platform. Boulders were then added to the platform to increase habitat diversity and roughness.

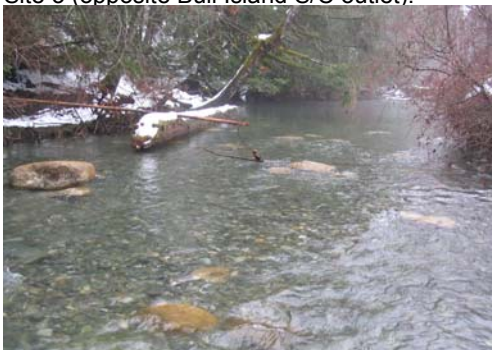
7. Completed spawning platform at Site 3 (opposite Bull Island S/C outlet).

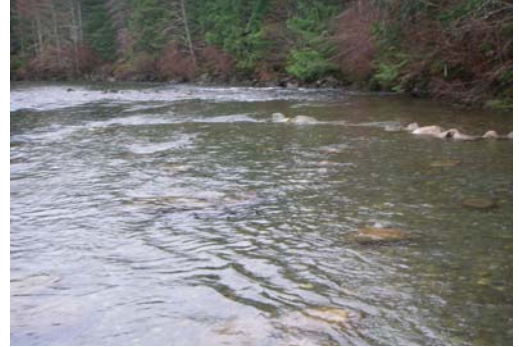
2. Completed spawning platform at Site 1 (Barber's Pool).

Construction of the spawning pad at Site 1, along the right bank of Barber's Pool, began August 23 as gravel was delivered to the site. A total of 326 metric tonnes (185 m<sup>3</sup>) of spawning gravel and four loads of large boulders were delivered and dumped on the prepared ramp. Gravel was then installed to create approximately 303 m<sup>2</sup> of spawning habitat. Mean gravel depth at this location was approximately 0.6 m, while water depths averaged 0.35 m. The gravel pad at this location was also complexed with boulders following spawning pad creation.

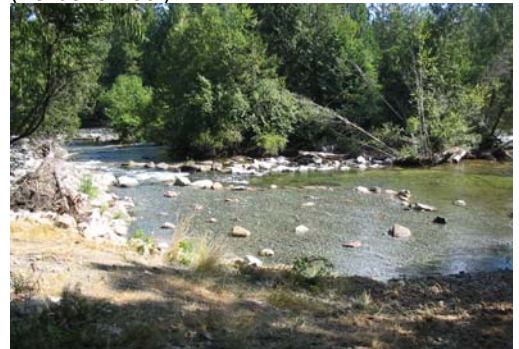
4. Completed spawning platform at Site 2 (upstream Bull Island Side-channel intake).

Construction at Site 2, located immediately upstream of the Bull Island Side-channel intake dike, occurred on August 11. Approximately 153 metric tonnes (87 m<sup>3</sup>) of spawning gravel and three loads of boulders were stockpiled on the access ramp. Gravel was installed and spread to create approximately 170 m<sup>2</sup> of spawning habitat, with a mean gravel depth of approximately 0.5 m. Following gravel pad creation, large native boulders delivered to the site were used to complex the spawning platform.

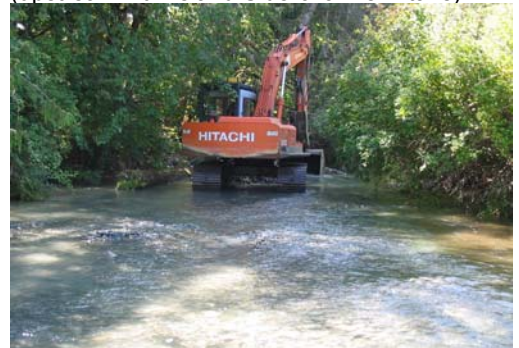
6. Gravel pad creation by excavator at Site 3 (opposite Bull Island S/C outlet).

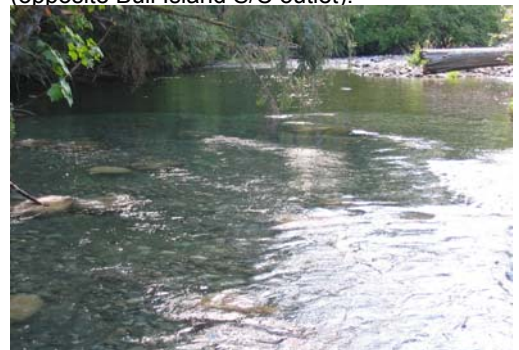
8. Completed spawning platform at Site 3 (opposite Bull Island S/C outlet).
