Puntledge River (Reach C) Spawning Gravel Placements for Fish Habitat Restoration, 2005

Scott Silvestri, B.Sc., Dip. Fisheries
BC Conservation Foundation
#3 – 1200 Princess Royal Avenue
Nanaimo, BC, V9S 3Z7

March 2006

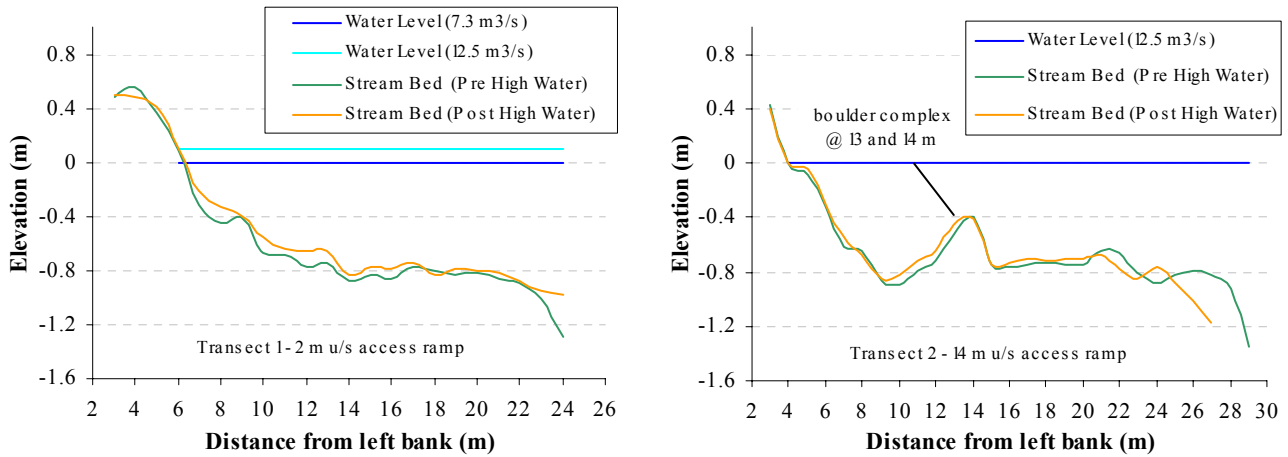
Figure 3. Gravel pad profiles at Site 1 before (October 25, 2005) and after (March 23, 2006) high water events. Elevations adjusted for water height.

At Site 1, streambed profiles confirmed snorkel survey findings that noted little gravel movement following high water (Figure 3). Minor changes in gravel pad height can likely be attributed to rod positioning error. Gravel placed at the outside edge of the pad, near the thalweg, appeared to have been flattened during high water. In addition, gravel displaced from the outside edge of the pad near the upstream end (i.e., Transect 2) appeared to have settled along the outside of the pad at the downstream end (Transect 1).

One small but recent redd/test redd was noted at Site 1, indicating digging by a resident trout or captive brood steelhead (released in October of 2005). In addition, most of the gravel pad and complexing boulders were covered by a layer of green filamentous algae and *Didymosphenia geminata* (diatom species). The abundance of both decreased significantly downstream of the first series of riffles leading into Barber's Pool and was not present at all at Site 2 (~ 3.5 km downstream).

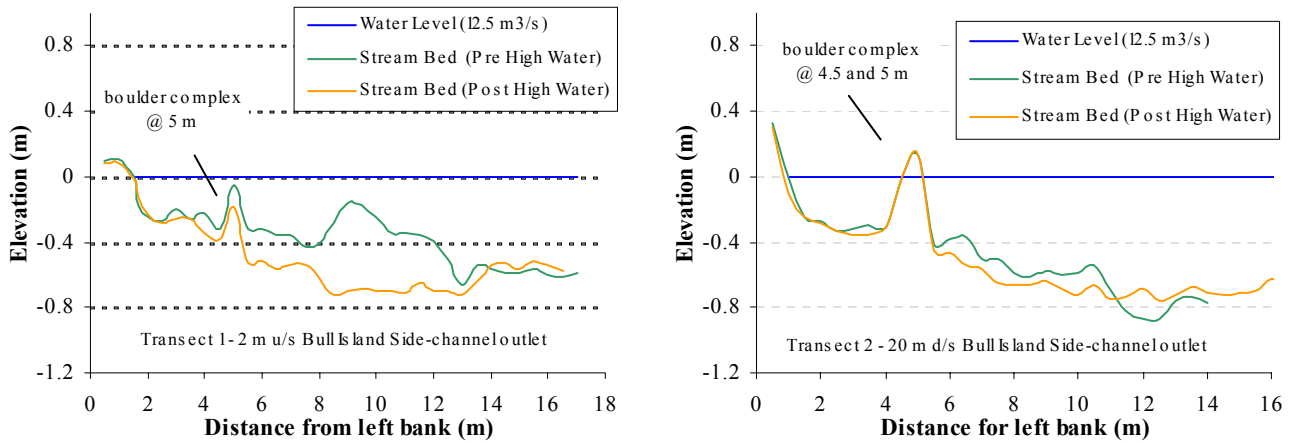
Figure 4. Gravel pad profiles at Site 2 before (October 25, 2005) and after (March 23, 2006) high water events. Elevations adjusted for water height.

At Site 2, significant gravel movement was noted at Transect 1, while less gravel movement was observed at Transect 2 (Figure 4). Similar to Site 1, displaced gravel from the upstream ends of both pads at Site 2 appears to have settled out along the outside edge of each pad near mid-channel. Significant gravel displacement was noted between 5 and 13 m along Transect 1.

At Site 2, approximately 60% of the upstream pad was displaced up to 50 m downstream, fanning out across the channel, settling around large cobbles and adding to gravel already present. Remaining gravel appeared highly usable, with good depths and velocities for spawning. About 25% of the displaced gravel appeared usable at the time of survey.

Approximately 25% of Site 2's downstream pad was displaced, though losses appeared to have been partially replaced by the upstream pad. Material displaced downstream has settled into interstitial spaces around the large boulders. No recent use of the downstream pad by fish was noted. Displaced material from both sites was apparent in the bedrock pool upstream of the Comox Logging Road Bridge.

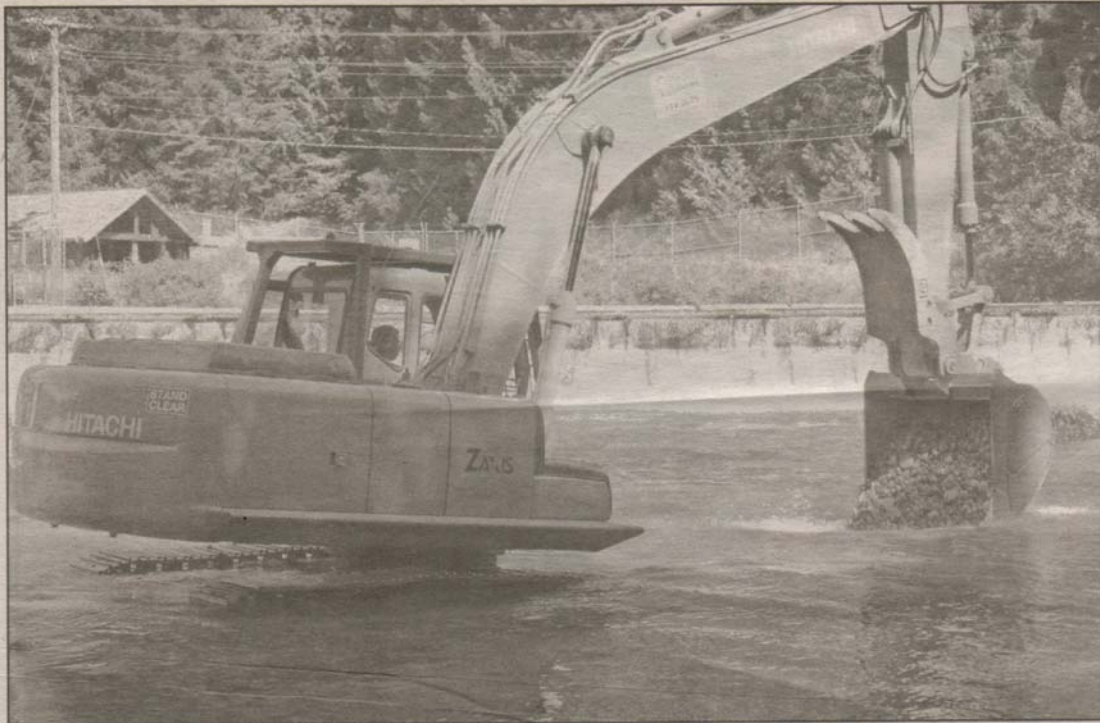
A FISH-SAFE EXCAVATOR placed gravel above Stotan Falls and below the diversion dam. The \$37,000 enhancement will provide about a 25 per cent increase in spawning habitat.

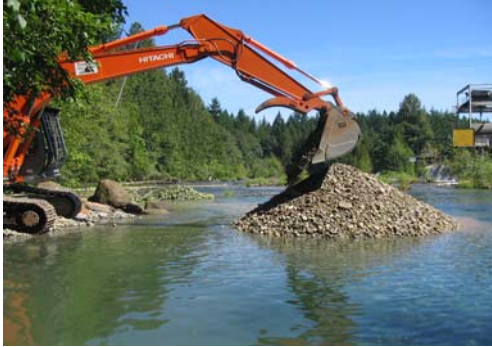
1. Gravel placement by excavator at Site 1 (Diversion Dam).

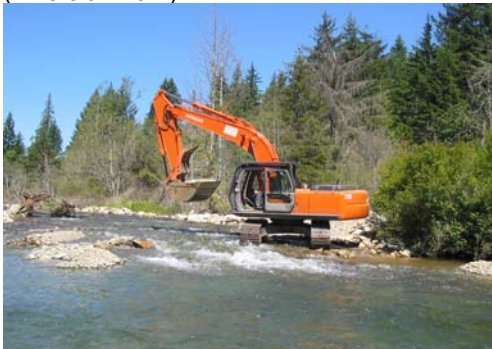
3. Gravel placement by excavator at Site 2 (Bull Island Side-channel).

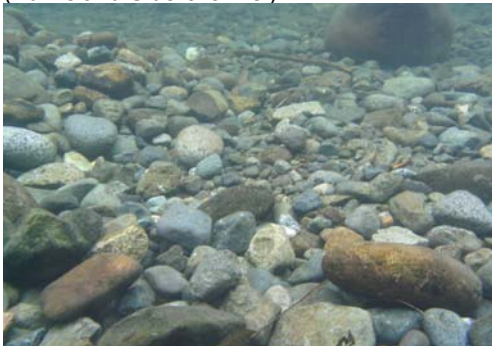
5. Possible chinook redd/test redd at Site 2.

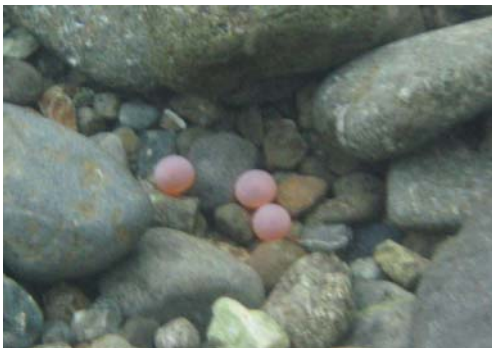
7. Viable chinook eggs from redd at Site 1.

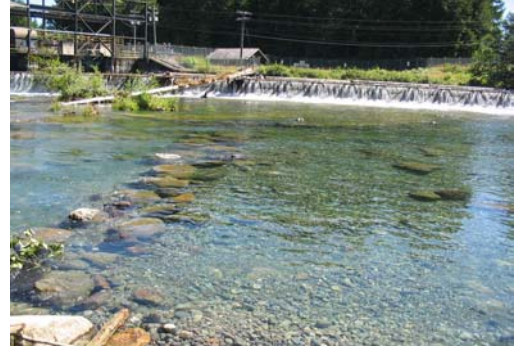
2. Completed spawning platform at Site 1 (Diversion Dam).

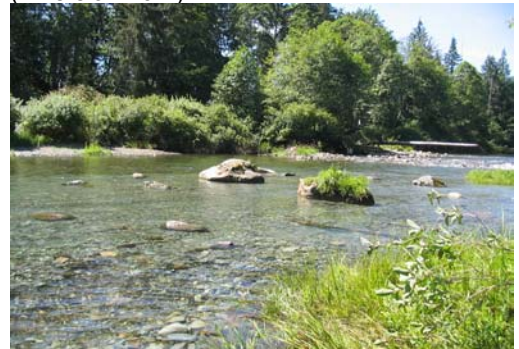
4. Completed spawning platform at Site 2 (upstream Bull Island Side-channel outlet).

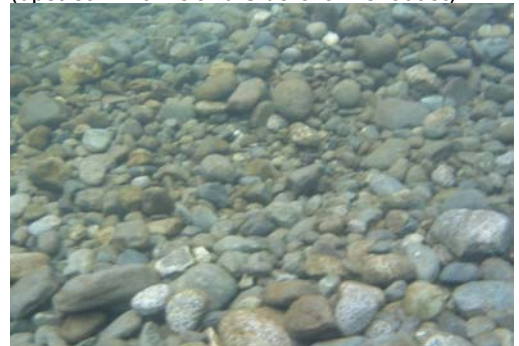
6. Confirmed chinook redd at Site 1.

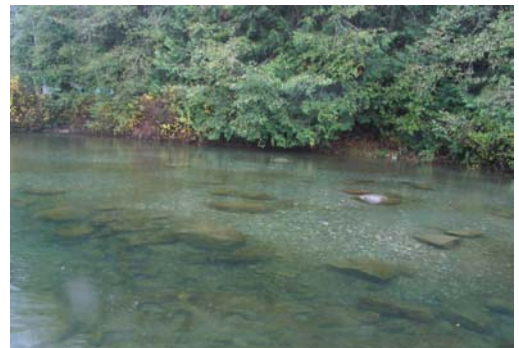
8. Spawning activity (likely chinook) at Site 1.

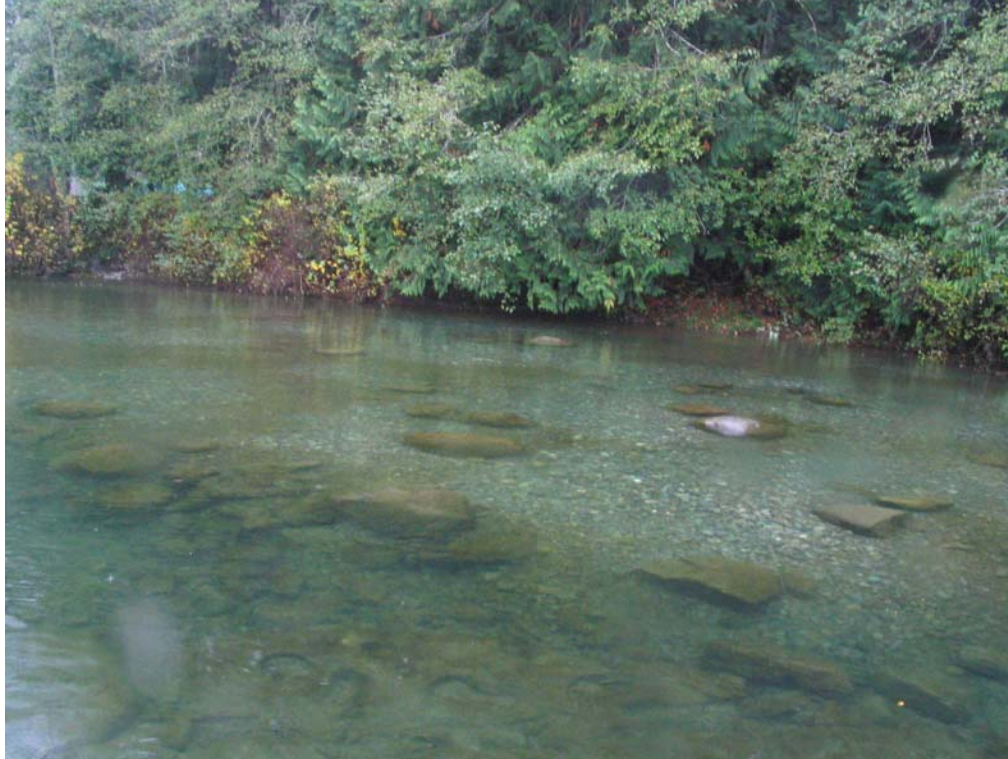
Photo 1. Looking upstream at gravel pad adjacent to the BC Hydro Diversion Dam in Reach C of the Puntledge River. The lighter gravel areas generally indicate redd/test redd locations.

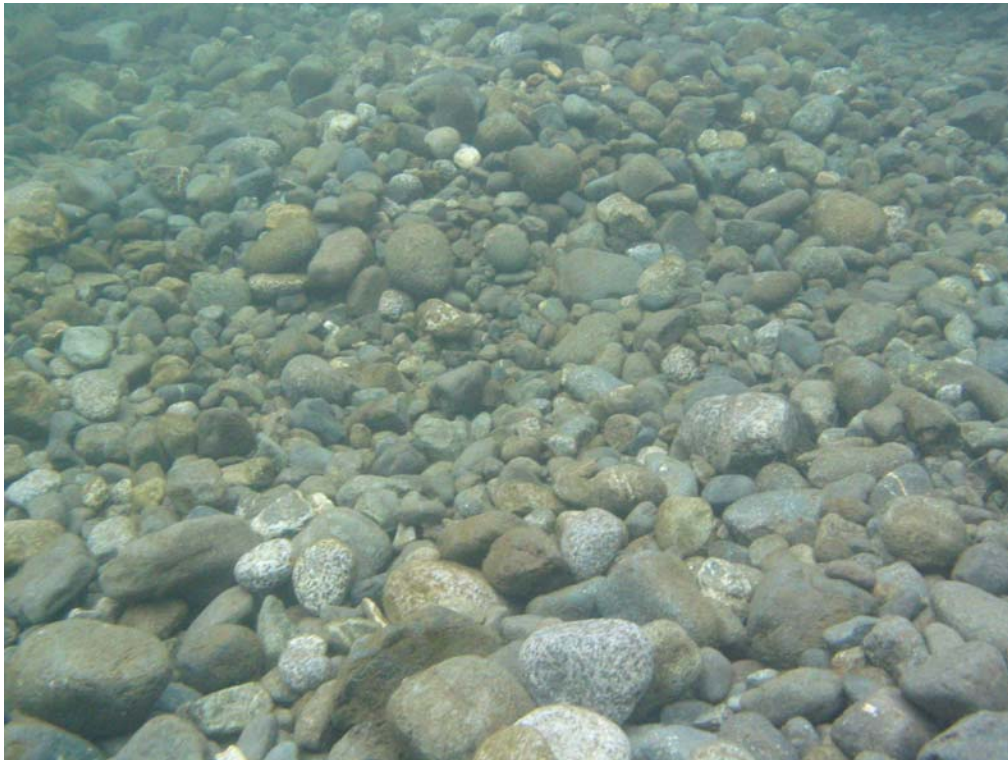
Photo 2. Confirmed redd located at downstream end of gravel pad adjacent to the BC Hydro Diversion Dam in Reach C of the Puntledge River. This redd was partially excavated to determine egg presence. Three large viable eggs (likely chinook) were found at this location.

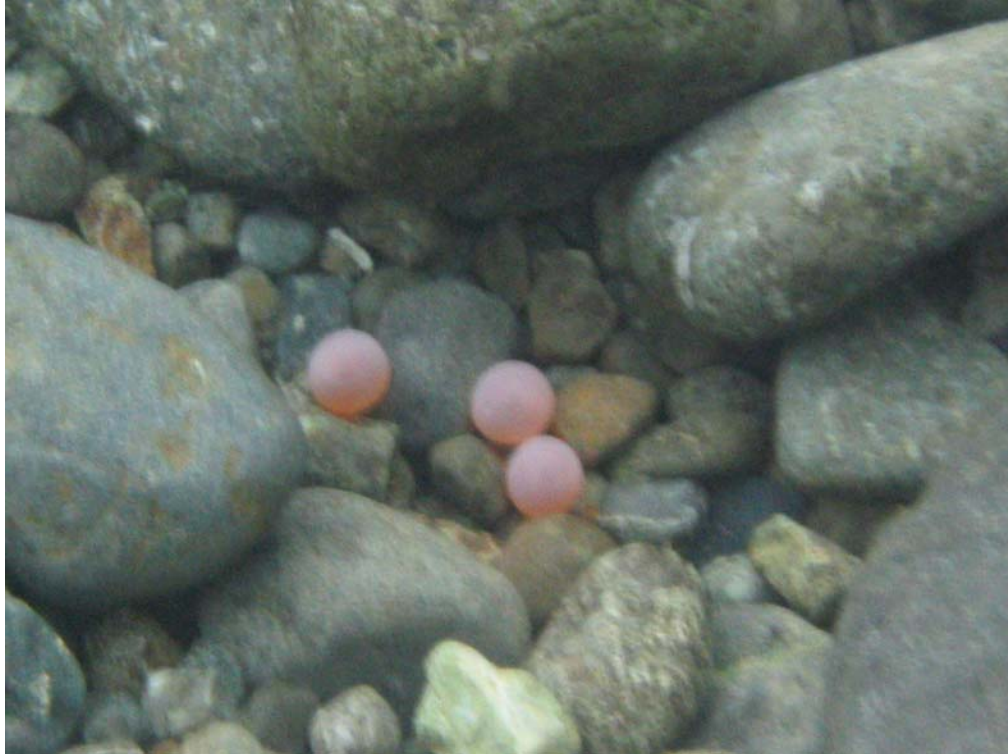
Photo 3. Viable eggs excavated from a redd near the downstream end of the spawning gravel pad adjacent to the BC Hydro Diversion Dam in Reach C of the Puntledge River.

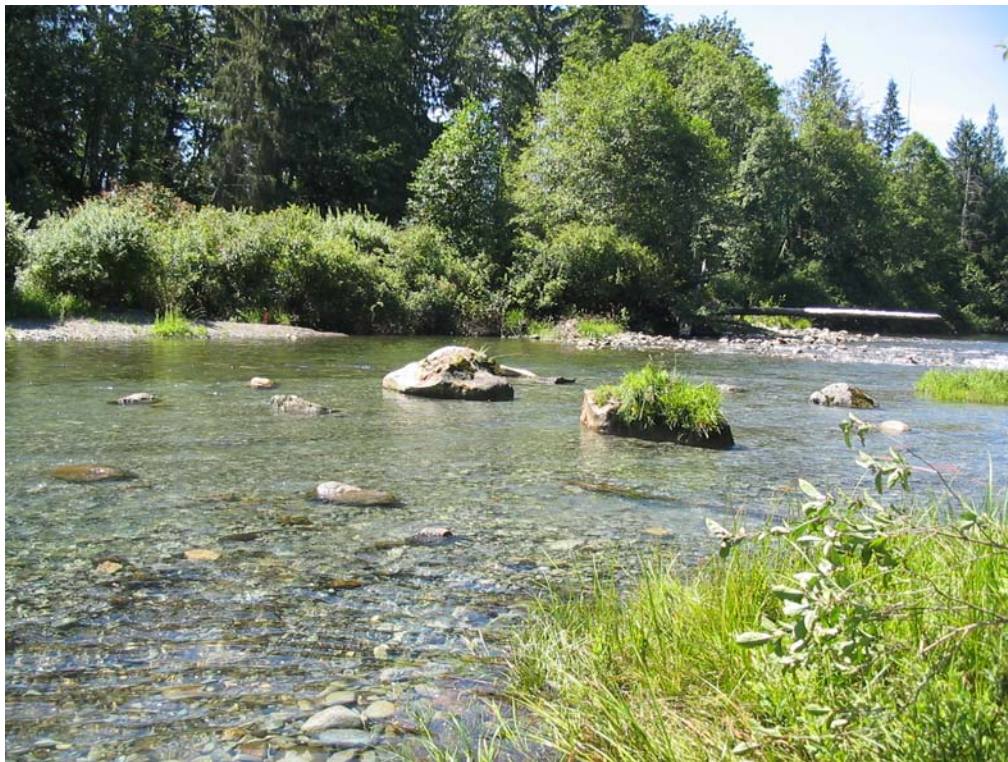
Photo 4. Looking upstream at gravel pad immediately upstream of the Bull Island Side-channel outlet (Left bank) in Reach C of the Puntledge River.

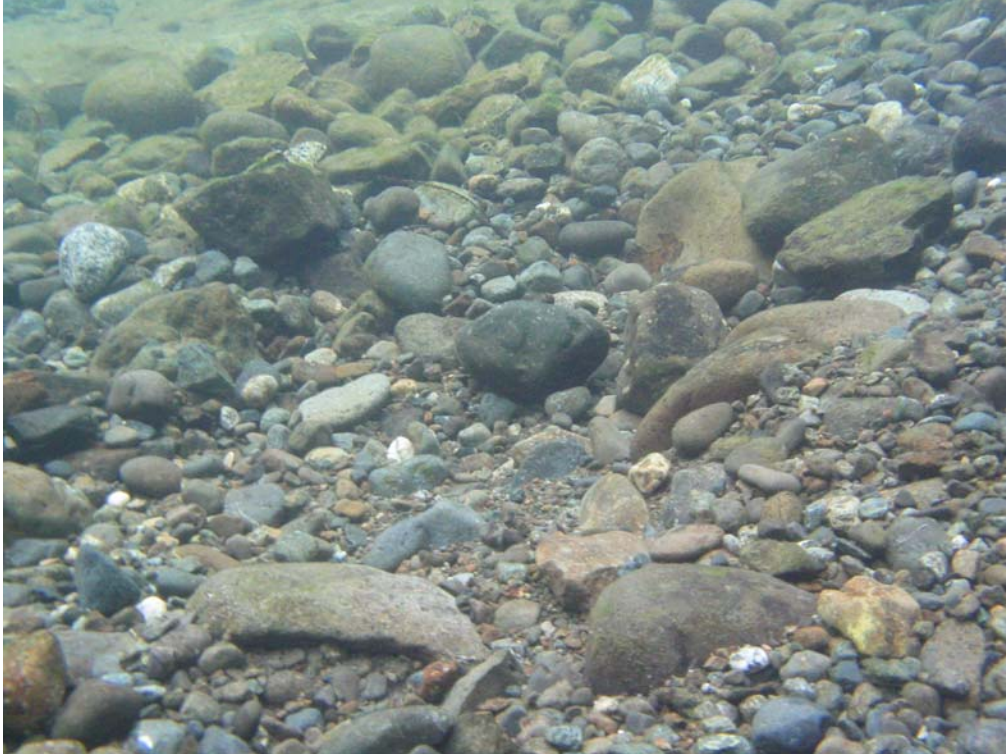
Photo 5. Possible redd/test redd located at downstream end of gravel pad immediately upstream of the Bull Island Side-channel outlet in Reach C of the Puntledge River. A few redd/test redds were partially excavated, however no eggs were found. A pair of actively spawning chinook salmon were observed at the downstream end of this gravel pad.
