# Spawning Gravel Placements in Ash and Nanaimo River Watersheds, Vancouver Island (2003)

*prepared by:*

**Brad Smith**

Habitat Conservation Trust Fund  
Victoria, BC  
Project # 2978128

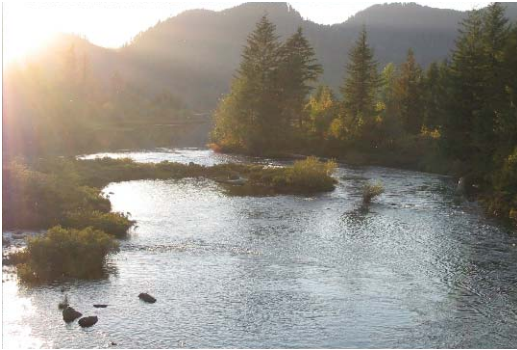
Photo 1. Outlet of Dickson Lake, Ash River watershed.

The outlet of Dickson Lake (Appendix C, photo 1) is accessed by the Ash River Mainline off Beaver Creek Road, north of Port Alberni. The lake is 120 ha in size, has a maximum depth of 16 m, and is elevated 207 m above sea level (Fish Wizard/BC Fisheries web site). As well as summer steelhead, the lake supports small stocks of resident cutthroat and rainbow trout, and Dolly Varden char.

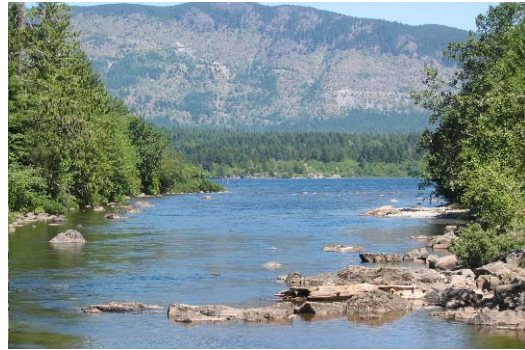
Photo 2. Stream channel that connects Second Lake to First Lake, upper Nanaimo River.

The stream channel that connects Second to First Lake is stable and ranges from 30 to 50 m in width, with relatively large, angular substrates poorly suited for spawning (Appendix C, photo 2). Gaboury and McCulloch (2002) documented an opportunity to improve spawning habitat for steelhead in the Nanaimo River, in the outlet of Second Lake, a short distance above First Lake. During adult steelhead snorkel counts, BCCF staff noted that substrates in this reach are poorly suited for spawning steelhead and rainbow trout. Juvenile production should be significantly increased in this reach with the addition of washed, screened spawning gravel.

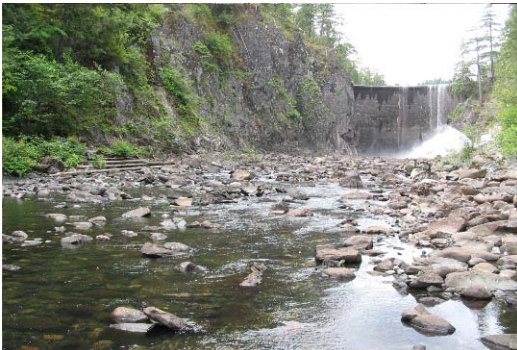
Photo 3. South Fork Dam, South Nanaimo River.

The South Nanaimo is the largest tributary in the Nanaimo watershed, with a drainage area of 210 km<sup>2</sup>. The river is flow controlled at South Fork Dam, 4.6 km upstream of its confluence with the Nanaimo River (Appendix C, photo 3). Over time, the quantity and quality of spawning material in the channel below the dam have diminished, as gravel was flushed-out of the system during high water events and not replaced naturally (Axford 1995). Jump Lake, managed by the Greater Nanaimo Water District (GNWD), is the primary domestic water supply for the City of Nanaimo.

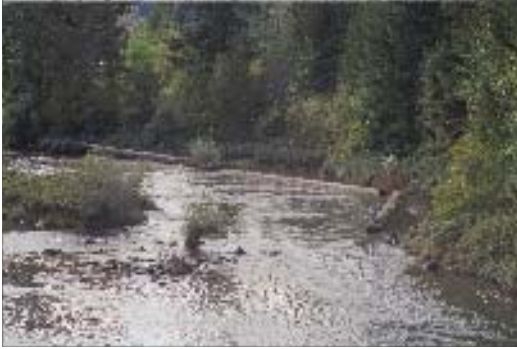
Photo 5. Proposed gravel site (Platform B), Dickson Lake outlet.

Based on prescriptions by MJL Consultants (2001), two sites were identified for spawning gravel placement in 2003 (Figure 4; Appendix C, photos 4-5), accessible via the campground on the north side (left bank) of the lake and a short spur road on the south side (right bank). Improvements to the left bank spur road were necessary using angular road base supplied by Dolans. Spawning gravel was staged at each location for placement at the proposed sites.

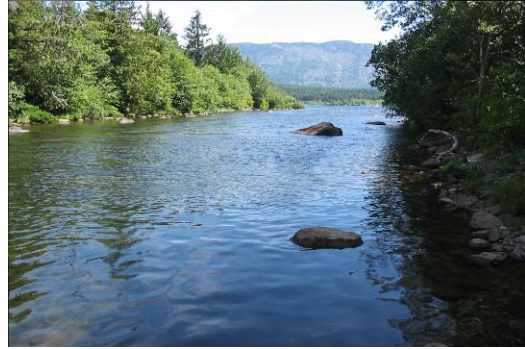
Photo 6. Proposed spawning gravel site, Second Lake outlet channel, Nanaimo River.

An assessment of the proposed site and potential access routes was made by the author on April 16, 2003 (Appendix C, photo 6). Permission to access TimberWest lands was granted on June 25, 2003 (Appendix B). An on-site meeting with TimberWest<sup>11</sup> occurred on July 8, 2003.

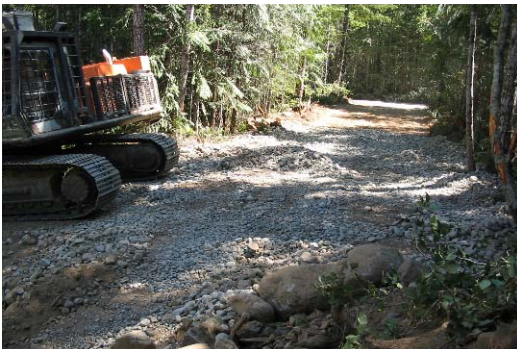
Photo 7. Spur road constructed to access site near Second Lake outlet, Nanaimo River.

TimberWest (Nanaimo Lakes Division) supplied an excavator and operator (in-kind; Appendix B). A 100 m spur road, required to access the site, was built on July 15 (Appendix C-photo 7). From July 17 to 19 a total of 150 m<sup>2</sup> of spawning material was delivered and stockpiled on the newly built road adjacent to the river.

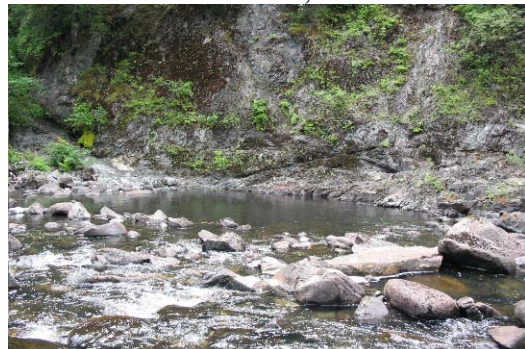
Photo 8. Proposed spawning gravel site #2, 60 m d/s South Fork Dam

Permission was granted by Weyerhaeuser Company Ltd. on July 1, 2003 for road access to the South Nanaimo River site (Appendix B). Three right bank sites were identified in a 200 m section immediately downstream of the dam (Figure 6; Appendix C, photos 8-9).

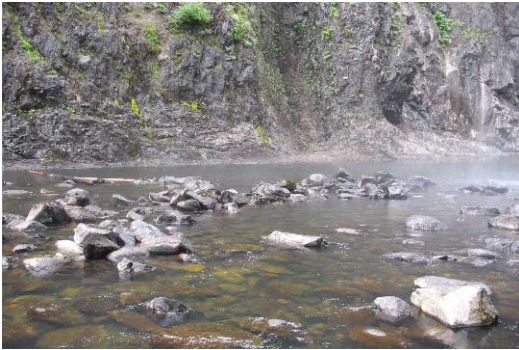
Photo 9. Proposed spawning platform site #3, 35 m d/s South Fork Dam

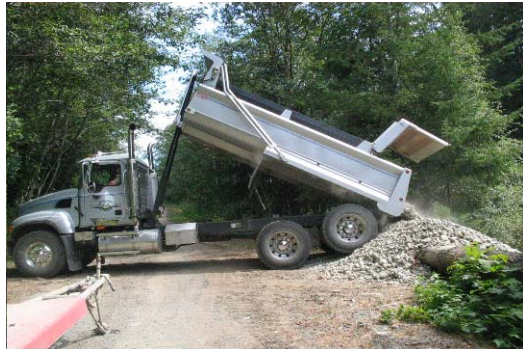
Photo 10. Gravel delivery down steep bank adjacent to South Nanaimo River.

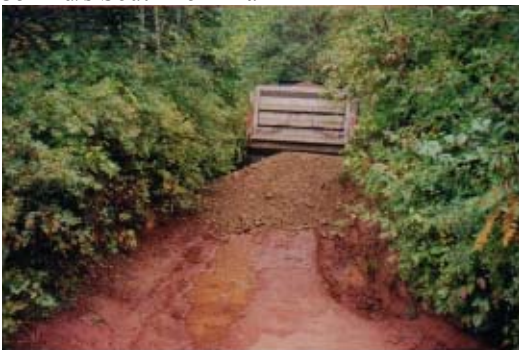
Photo 11. Road grade improvements at campsite near Dickson Lake outlet (left bank).

Originally scheduled for late July, gravel installation was completed September 18-19, 2003. Delays arose when poor road conditions made truck access impractical (Appendix C, photo 11). Province-wide road closures, in place to minimize forest fire risk, caused further unexpected delays from late August to September 15.

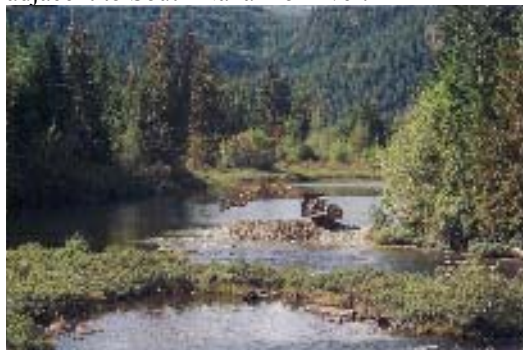
Photo 12. Upstream view of platform A construction, Dickson Lake outlet.

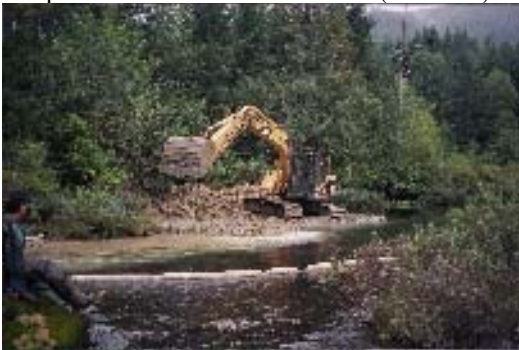
Photo 13. Upstream view of platform B construction, Dickson Lake outlet.

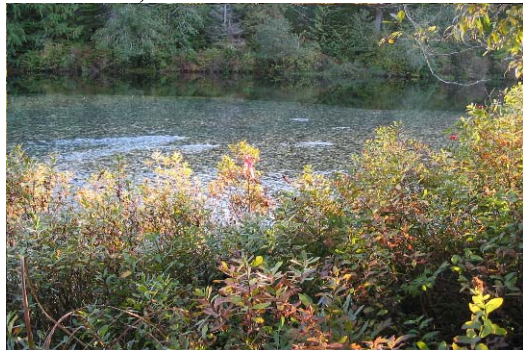
Photo 14. Cross stream view of platform A, Dickson Lake outlet.

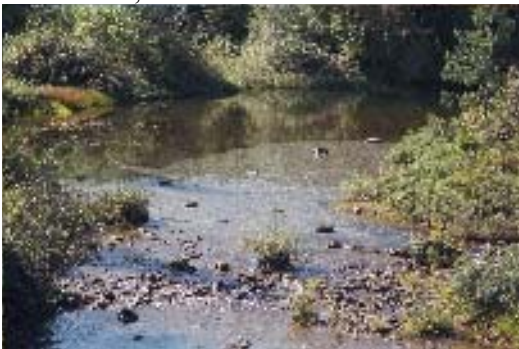
Photo 15. Upstream view of platform B, Dickson Lake outlet.

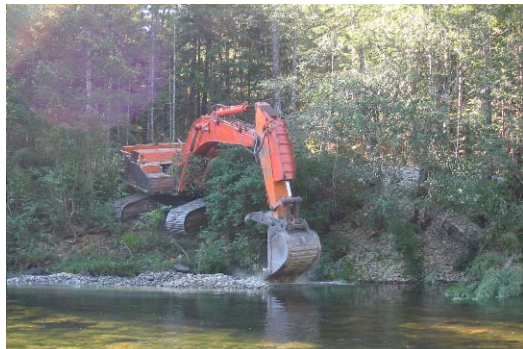
Photo 16. Excavator placing material into outlet channel, Nanaimo River.

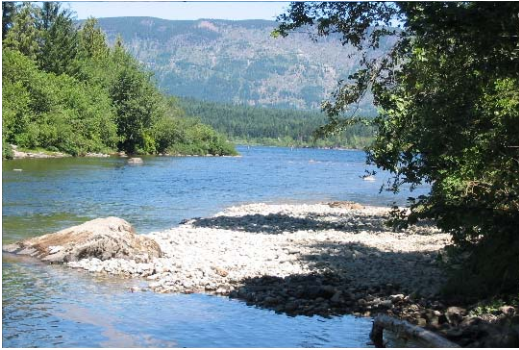
Photo 17. Downstream view of installed gravel, Nanaimo River.

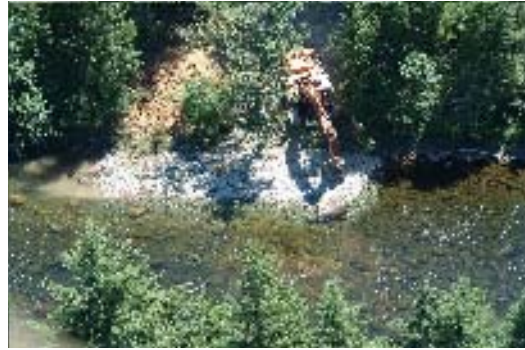
Photo 18. Aerial view of installed gravel, Nanaimo River.

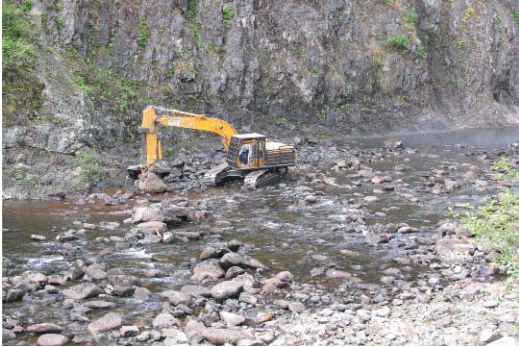
Photo 19. Excavator building route for front-end loader, South Nanaimo River

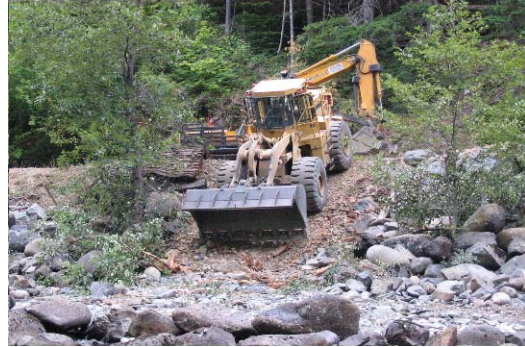
Photo 20. Access route into South Nanaimo River channel.

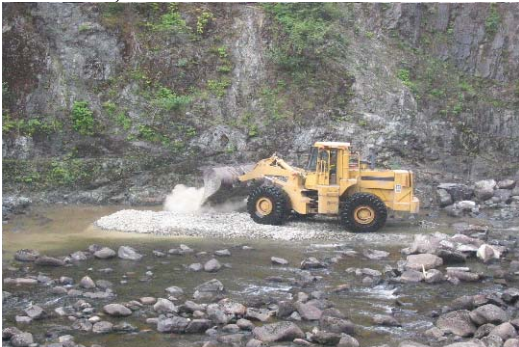
Photo 21. Front-end loader moving material into Site #2, South Nanaimo River.

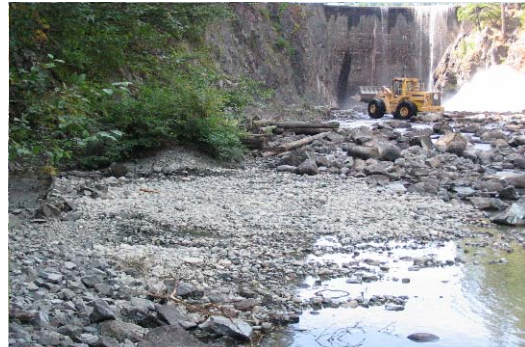
Photo 22. Upstream view of Site #2, South Nanaimo River.

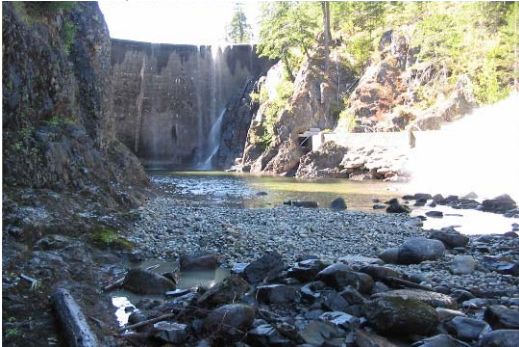
Photo 23. Upstream view of Site #3, South Nanaimo River.

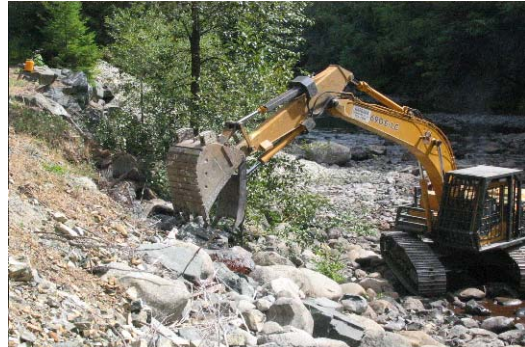
Photo 24. Armouring disturbed stream bank, South Nanaimo River.

Upon completion of each platform, the excavator replaced boulders removed to create loader routes. The disturbed river bank was restored and fortified with large boulders (Appendix C, photo 24). GNWD provided additional funding to rehabilitate the eroding rip-rap bank adjacent to their pumphouse facility.
